**DEPARTMENT OF TRANSPORTATION**

Contract #: 04-0120F4Cty: SF/ALA Rte: 80 PM: 13.2/13.9File #: 69.28**WELDING INSPECTION REPORT****Resident Engineer:**Siegenthaler, Peter**Address:** 333 Burma Road**City:** Oakland, CA 94607**Report No:** WIR-017949**Date Inspected:** 23-Oct-2010**Project Name:** SAS Superstructure**OSM Arrival Time:** 700**Prime Contractor:** American Bridge/Fluor Enterprises, a JV**OSM Departure Time:** 1900**Contractor:** Zhenhua Port Machinery Company, Ltd (ZPMC), Changxing Island **Location:** Shanghai, China**CWI Name:** Xu tao**CWI Present:** Yes No**Inspected CWI report:** Yes No N/A**Rod Oven in Use:** Yes No N/A**Electrode to specification:** Yes No N/A**Weld Procedures Followed:** Yes No N/A**Qualified Welders:** Yes No N/A**Verified Joint Fit-up:** Yes No N/A**Approved Drawings:** Yes No N/A**Approved WPS:** Yes No N/A**Delayed / Cancelled:** Yes No N/A**Bridge No:** 34-0006**Component:** OBG Components**Summary of Items Observed:**

# WELDING INSPECTION REPORT

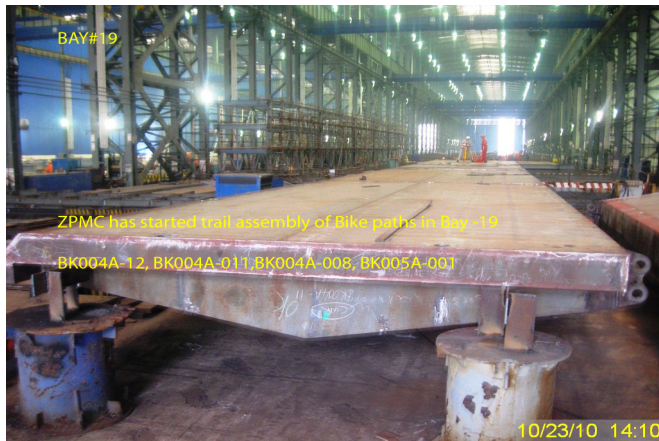
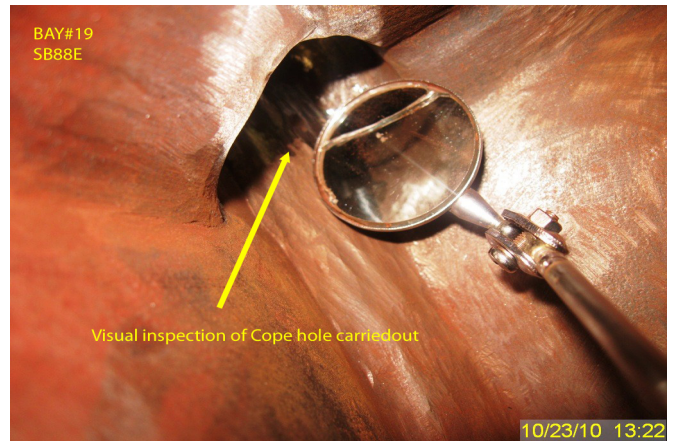
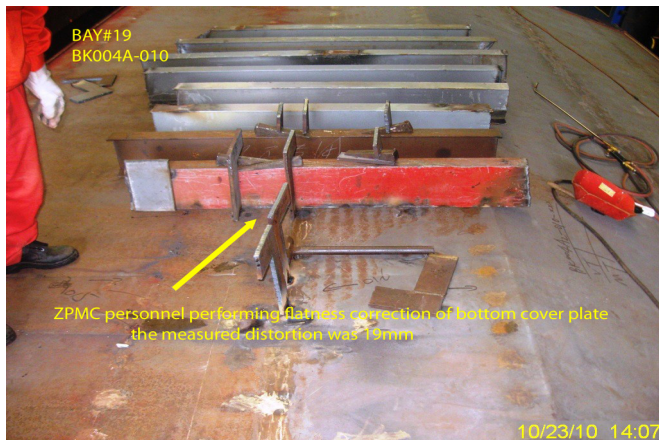
Flatness correction of bike path BK004A-010 weld is identified as BK004A2-016,018 is carried out by ZPMC personnel as approved report HSR1 (B)-9501.

ZPMC QC NDT personnel performing MT of bottom cover plate is identified as BK004A-009

Visual inspection of Cope holes carried out in following suspender bracket SB88E. locations where need additional grinding and welding marked and repaired by ZPMC personnel.

This QA inspector performed MT 15% of weld areas previously tested and accepted by ZPMC Quality Control personnel. This QA inspector generated an MT report for this date. The members are identified as OBG Suspender bracket and Bike path. The weld designations reviewed as follows.
